Research Organics, Inc. is submitting the attached independent professional engineering assessment from HB Engineering, Inc., North Royalton, Ohio concerning repairs to our Hazardous Waste Tank (T004). This assessment was performed in compliance with regulations in 40 CFR 265.196. The documentation will be placed in the operating record and maintained until closure of the facility.

Ref.: Repairs for Hazardous Waste Storage Tank No. 4.

Field Pictures

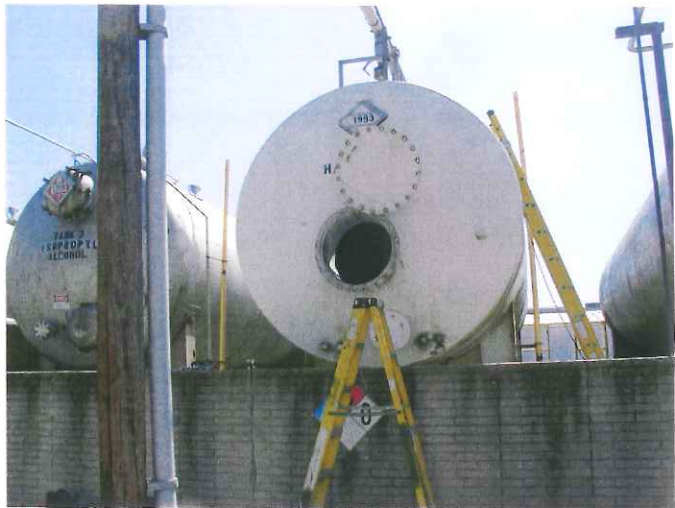
A minor dripping was detected during normal daily inspection of the tank coming from the bottom, south of the fill pipe and above the front saddle support. The tank was taken out of service, emptied, and inspected on September 8, 2008. The inspection revealed several pitted areas on the inside surface at the bottom of the tank. There was no loss of any of the tank contents to the secondary containment.

Tank No. 4 During Inspection

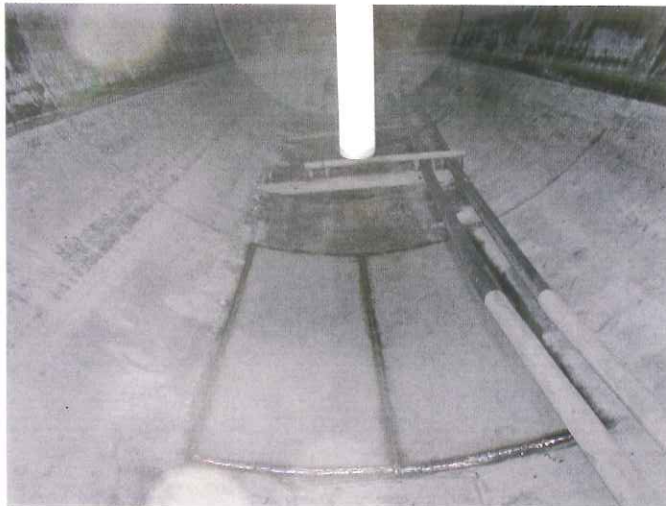
The repaired area was tested on September 11, 2008 by the undersigned using an ultrasonic thickness gauge. The results show a wall thickness of 0.29 inches. The internal and external surfaces of the tank were examined and found free of cracks, weld breaks, and corrosion.

Tank No. 4 Showing Repaired Area

Research Organics, Inc. upon consultation with the contractor and me it was decided that a patch made of stainless steel would be needed to be welded over the entire area on the inside of the tank. Two (2) stainless steel plates - 0.25" thick were rolled to match the tank curvature and fit into the manway hatch, each approximately 18 x 60 inches. These two (2) pieces were welded to the tank bottom to cover the pitted areas.

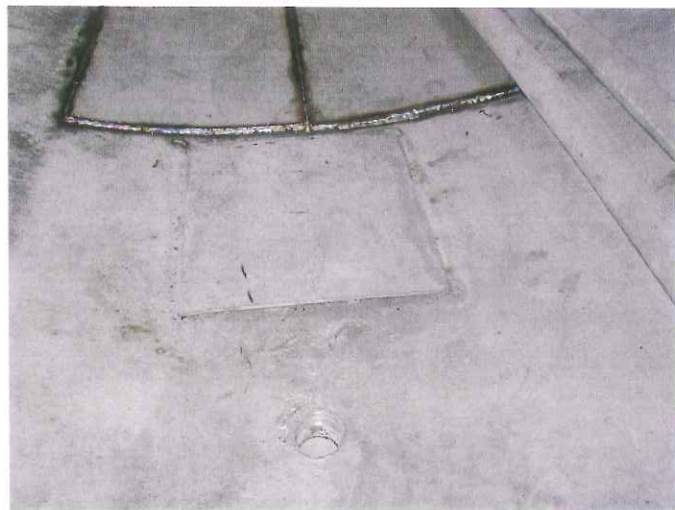
**Deflector Plate Placed Underneath
the Submerged Fill Pipe**

The tank system utilizes a submerged fill pipe to comply with the air pollution control rules. As a result of filling close to the tank bottom, the facility installed a deflector plate made of 304 stainless steel placed underneath the fill pipe to protect the tank wall during filling.

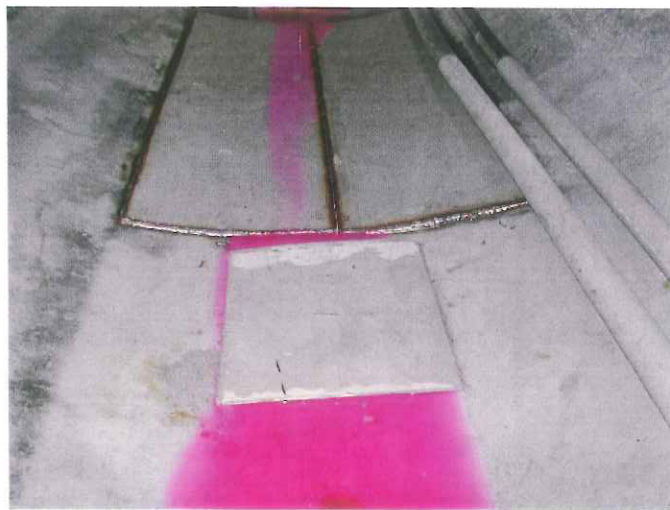
In order to assure the integrity of the welded area, a dye test was conducted using a fluorescent red dye tablet placed in water inside the tank. There was no dripping noticed on the outside surface of the colored water. Thereafter I informed Mr. Kolesar that the repairs are satisfactory and that Research Organics, Inc. can use the tank system.

**Fluorescent Red Dye was used for
Leak Detection**
